LAKE CLASSIFICATION REPORT GOOSE LAKE, ADAMS COUNTY

**Presented by Reesa Evans, CLM, Lake Specialist
Adams County Land & Water Conservation Department
P.O. Box 287, Friendship, WI 53934**

MARCH 2008

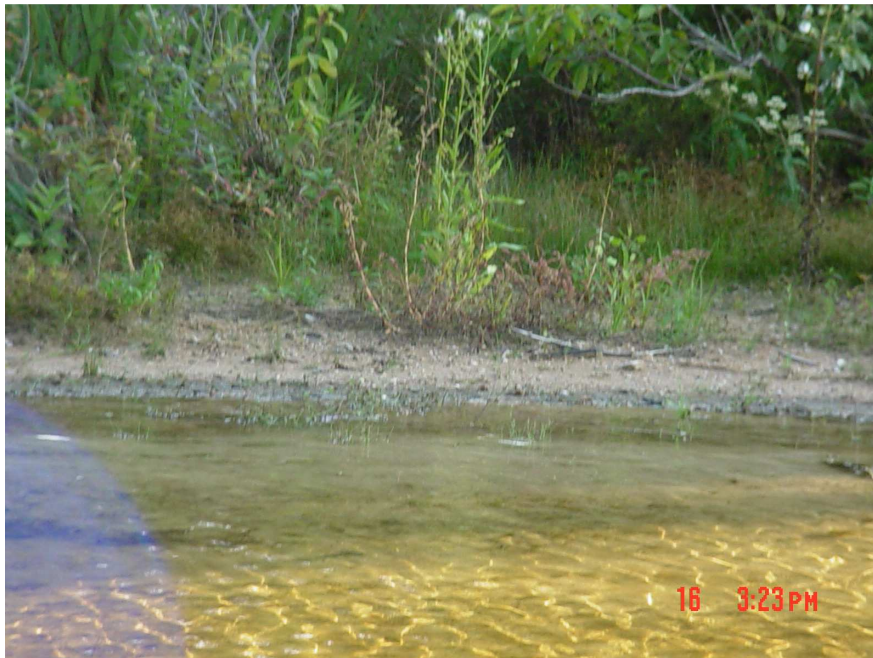
Figure 7: former shoreland wetland area on Goose Lake now exposed

Wetlands play an important role in maintaining water quality by trapping many pollutants in runoff and flood waters, thus often helping keep clean the water they connect to. They serve as buffers to catch and control what would otherwise be uncontrolled water and pollutants. Wetlands also play an essential role in the aquatic food chain (thus affecting fishery and water recreation), as well as serving as spaces for wildlife habitat, wildlife reproduction and nesting, and wildlife food.

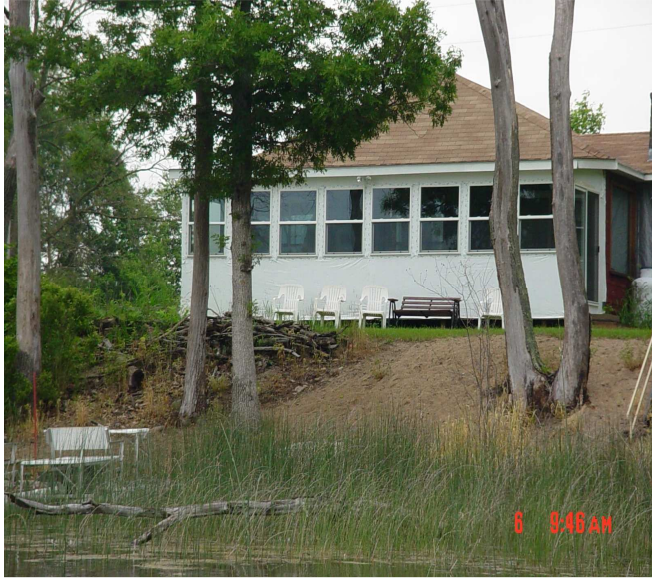
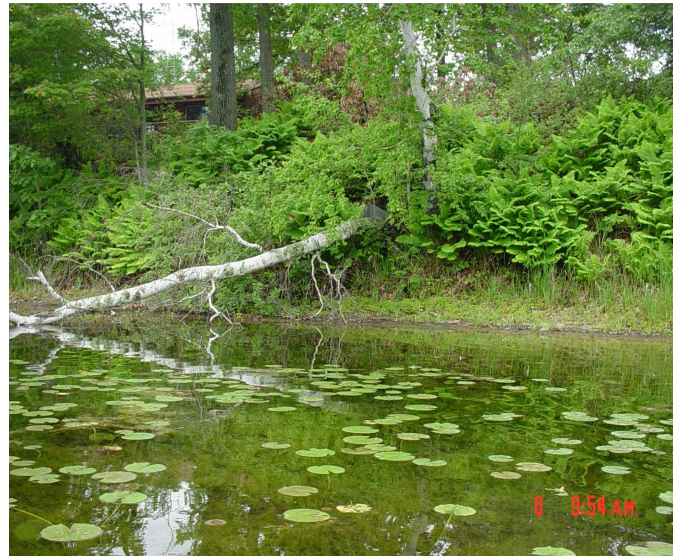
Figure 12a: Example of Inadequate Buffer

Figure 12b: Example of Adequate Buffer

The 2004 inventory included classifying areas of the Goose Lake shorelines as having “adequate” or “inadequate” buffers. An “adequate” buffer was defined as one having the first 35 feet landward covered by native vegetation. An “inadequate” buffer was anything that didn’t meet the definition of “adequate buffer”, including native vegetation strips less than 35 feet landward. Using these definitions, 57.35% (8479.2 feet) of Goose Lake’s shoreline had an “adequate buffer”, leaving 42.65% (6304.8 feet) as “inadequate.” Most of the “inadequate” buffer areas were found with mowed lawns and/or insufficient native vegetation at the shoreline to cover 35 feet landward from the water line.

Vegetated shoreland buffers help stabilize shoreline banks, thus reducing bank erosion. The plant roots give structure to the bank and also increase water infiltration and decrease runoff. A vegetated shore is especially important when shores are steep and soft, as are many of the Goose Lake shores. Figure 11 maps the adequate and inadequate buffers on Goose Lake.

Adequate buffers on Goose Lake could be easily installed on most of the lake by either letting the first 35 feet landward from the water just grow without mowing it, except for a path to the water, or—if something more controlled or aesthetically pleasing was desired—by planting native seedlings sufficient to fill in the first 35 feet.

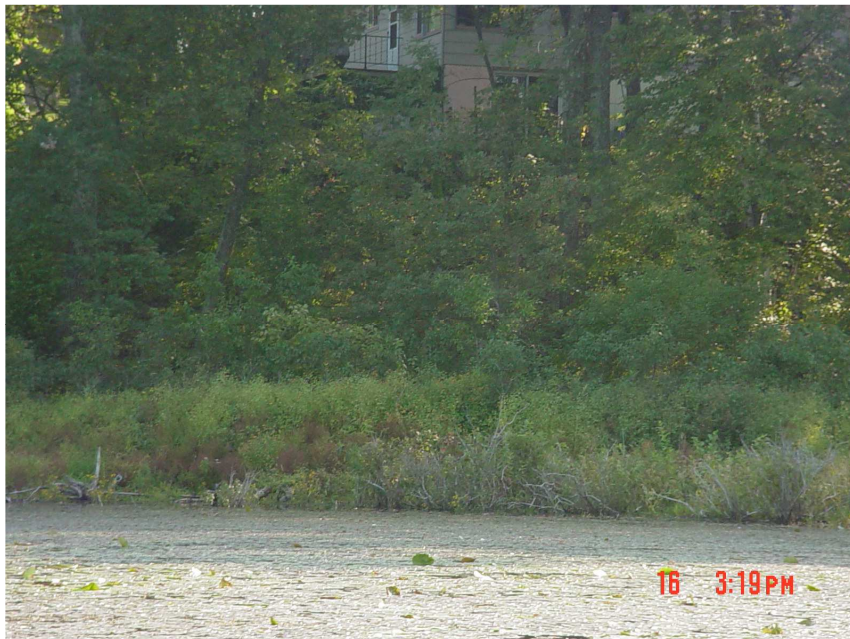
**Figure 13:
Example of
Vegetated
Shore on
Goose Lake**

The boat ramp and small beach area are located on the east side of the lake. They are at the end of fairly steep, paved area that leaves them vulnerable to both water and wind erosion. A rainstorm in 2006 washed out some sections of the boat ramp. Plans are to repair the boat ramp in the next two years to make the boat ramp safe and should to protect this area from further erosion. If appropriately done, this would also keep some soil particles from ending up in the lake.

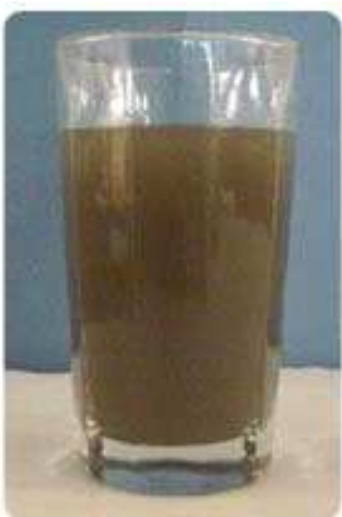
**Figure 32:
Examples of Very
Turbid Water**

TURBIDITY: Turbidity reflects water clarity. The term refers to suspended solids in the water column—solids that may include clay, silt, sand, plankton, waste, sewage and other pollutants. Turbid water may mask the presence of bacteria or other pollutants because the water looks murky or muddy. In general, turbidity readings of less than 5 NTU are best. Very turbid waters may not only smell, but also tend to be aesthetically displeasing, thus curtailing recreational uses of the water. Turbidity levels for Goose Lake's waters were 2.01 NTU in 2004, 1.95 NTU in 2005, and 1.79 NTU in 2006—all very low levels.

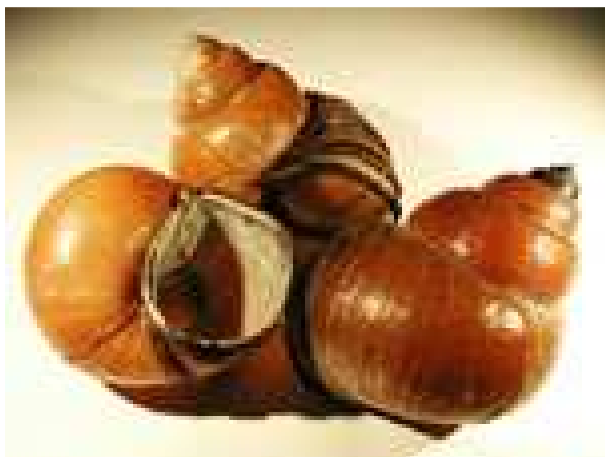
Chinese Mystery Snail

Figure 45: Photos of the Invasive Mystery Snails

Banded Mystery Snail

In 2007, Chinese mystery snails (*Bellamya japonica*) and Banded mystery snails (*Viviparus georgiana*) were found in Goose Lake. These are relatively new invaders to Wisconsin. The WDNR and Center for Limnology at UW-Madison are currently studying these snails in an attempt to better determine their potential impact on Wisconsin lake ecosystems. They are analyzing the data to see how the snail's presence correlates with native snail abundance, water chemistry, etc. The Center for Limnology has also completed a large, outdoor experiment examining how Chinese mystery snails and rusty crayfish affect native snails. The preliminary results are clear-cut -- both invaders have strong negative effects on the natives. The Chinese mystery snail, owing to its larger size, is relatively immune from rusty crayfish attack while other snails are often fed on by the rusty crayfish.

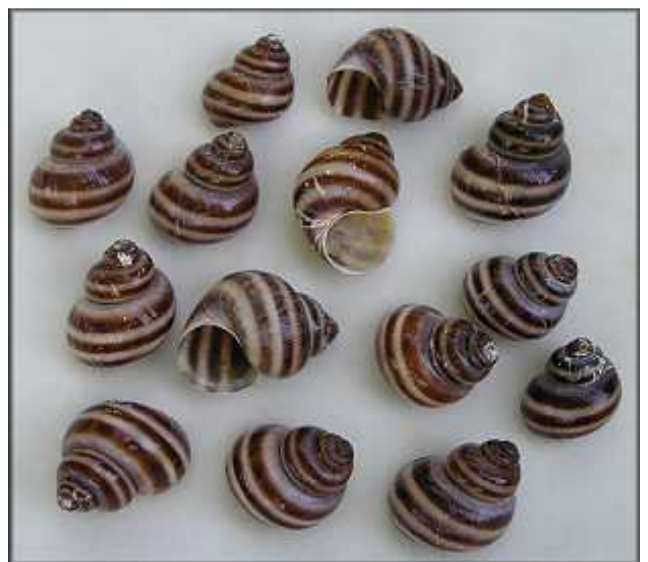
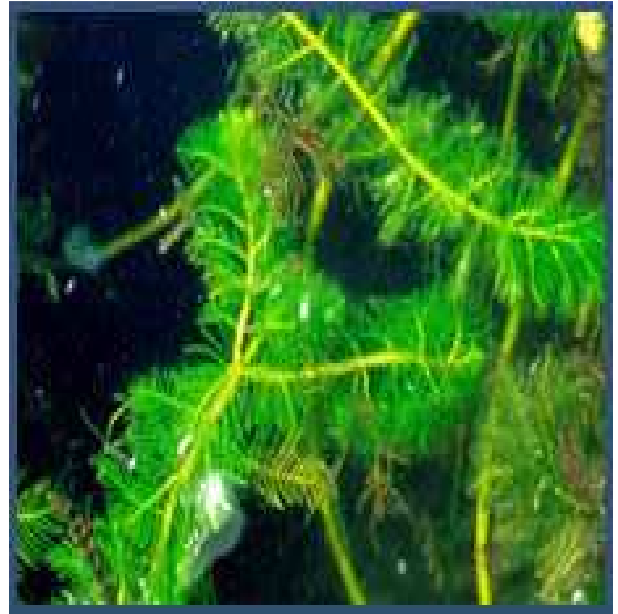
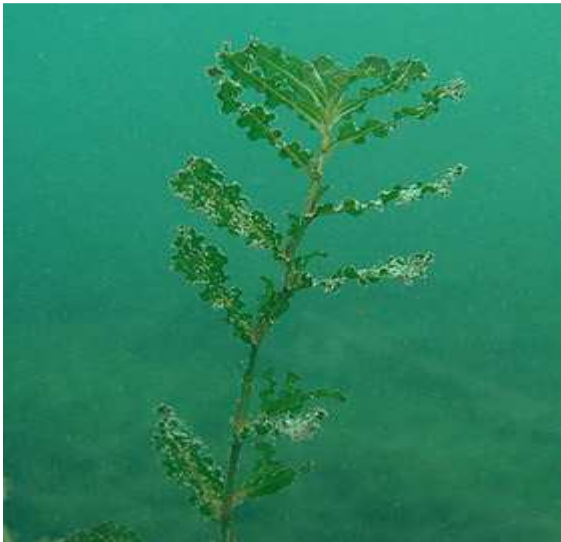
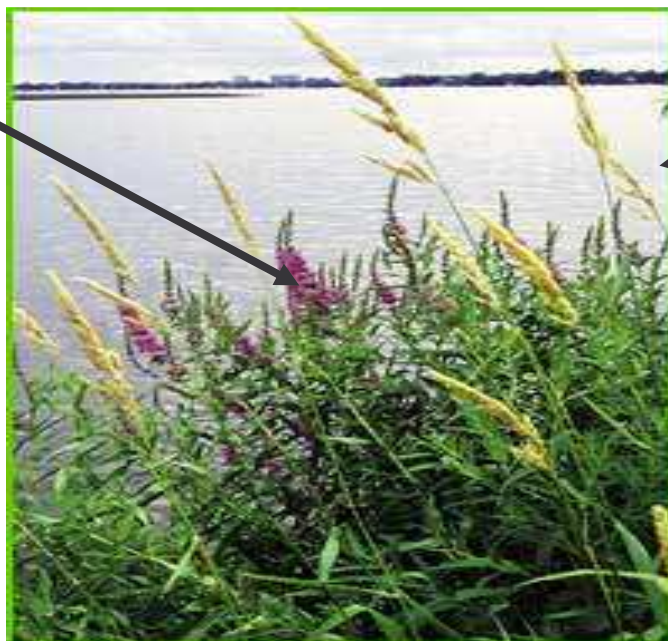
Figure 46: Invasive Aquatic Plants Known to Occur in GooseLake: *Myriophyllum spicatum* (Eurasian Watermilfoil); *Potamogeton crispus* (Curly-Leaf Pondweed); *Phalaris arundinacea* (Reed Canarygrass); and *Lythrum salicaria* (Purple Loosestrife)

The invasive Eurasian Watermilfoil has been in Goose Lake for some years. It tends to accumulate in large mats in the shallower areas of the lake, including right off the boat ramp. Based on its distribution pattern, during much of the summer it is impossible for a boat to launch at the public boat ramp and travel to other parts of the lake without going through Eurasian Watermilfoil and spreading it by fragmentation. The Goose Lake Association has chemically spot-treated the lake for several years in an attempt to control the spread of EWM.

Although Curly-Leaf Pondweed, Purple Loosestrife and Reed Canarygrass are also found at Goose Lake, none of them occur in significant frequency or density at this time.

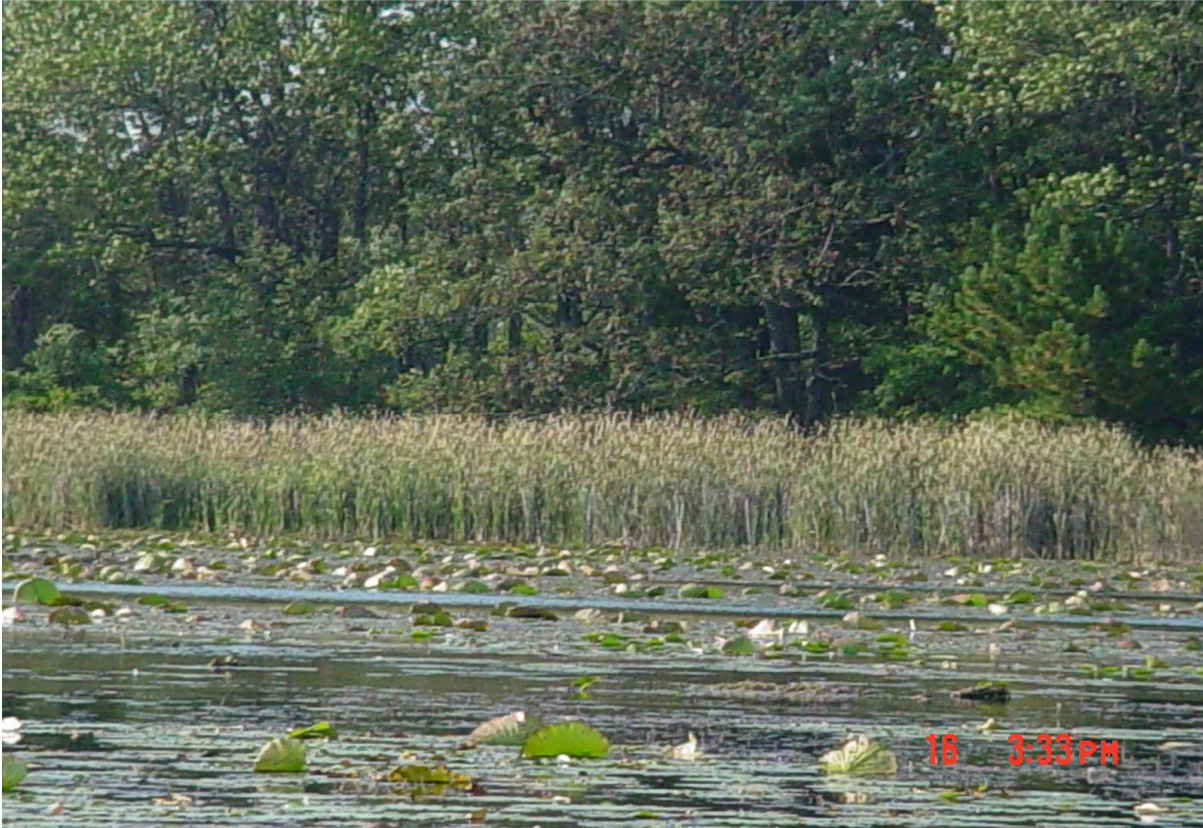
Figure 48: View of GL1 Southeast side

The fallen woody debris along the shore and mosaic of submerged vegetation and floating-leaf vegetation with an open area provides a diversity of habitat and feeding opportunities for the fish community. This basin provides spawning, nursery, feeding and cover for northern pike, large-mouth bass, perch, panfish, suckers and bullheads.

The variety of emergent vegetation, floating-leaf vegetation, shrubs and snag trees provide cover and feeding areas for upland wildlife; shelter, cover, nursery and feeding areas for beaver, otter, muskrat & mink; cover, nesting & feeding for raptors, ducks, songbirds and geese; cover, feeding & nesting for amphibians and reptiles.

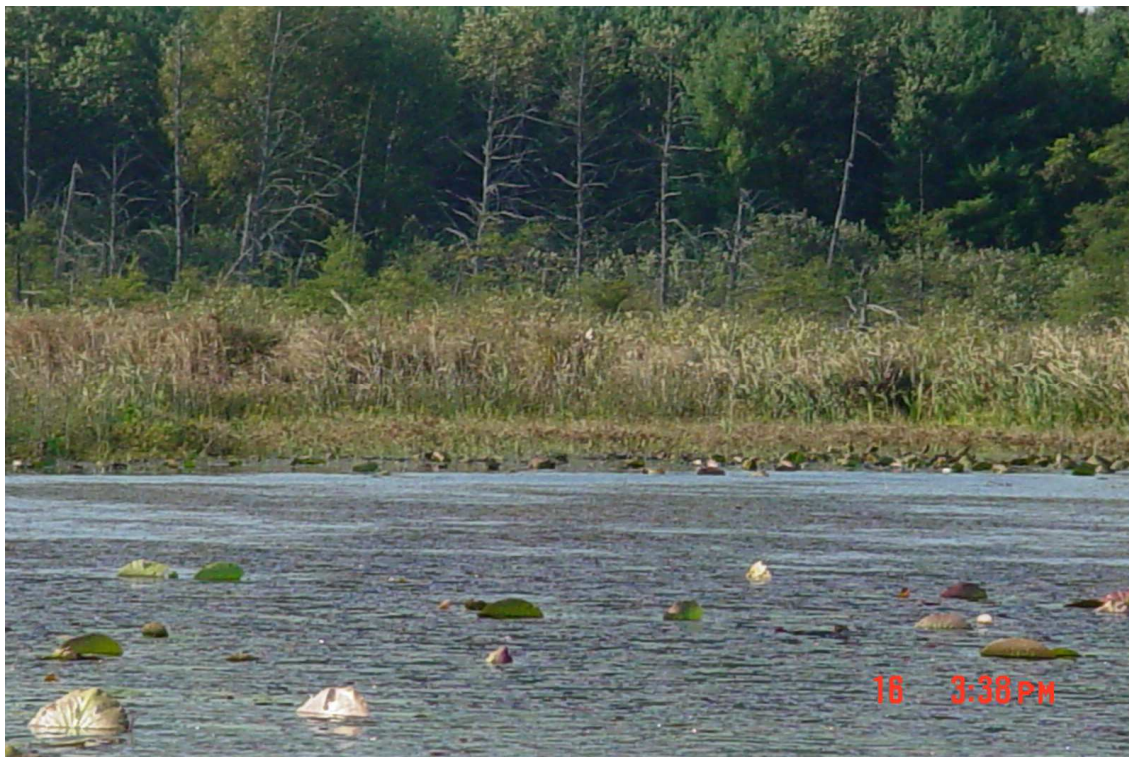
Figure 49: Close-Up of West Side of GL2

Maintaining the integrity of this area is important to protect the water quality of Goose Lake. The submerged and floating-leaf vegetation take up nutrients into their tissues that would otherwise be available for algae growth or overly-dense plant growth. The emergent vegetation on the west shore filters water that runs off the steep west shore. The submergent vegetation is protecting the lake bottom from resuspension of the fertile muck and peat sediments by boat traffic and wind action, thus maintaining clarity.

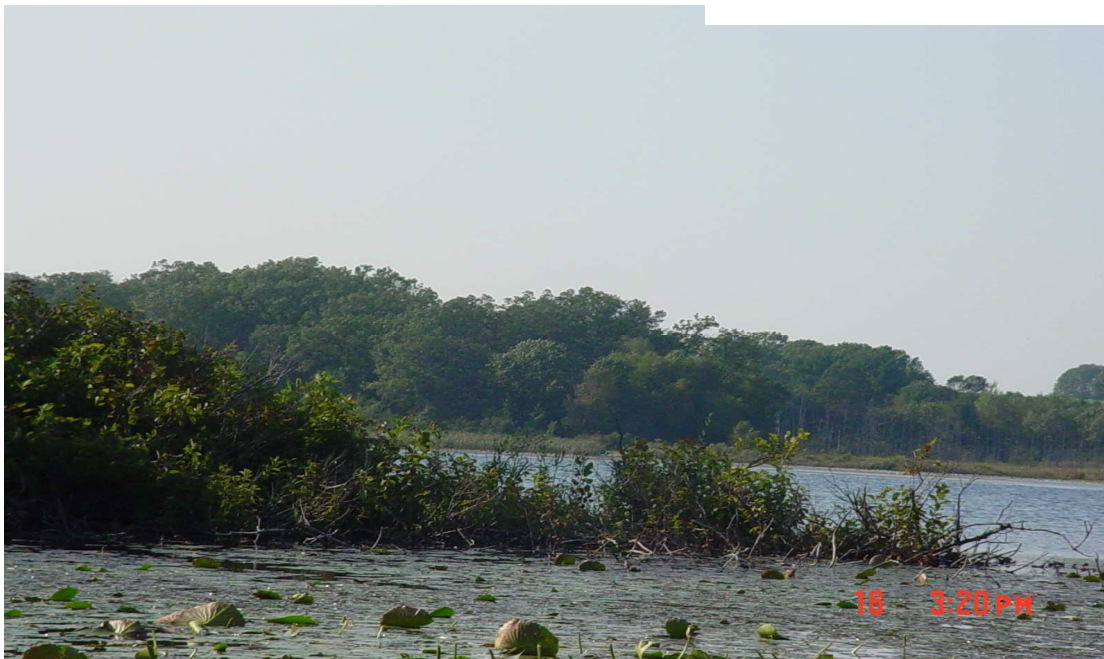
Figure 50: Point Area in GL3

An emergent species of special concern, *Eleocharis robbinsii*, was abundant in this area. Also found were four emergent species, four floating-leaf rooted species, and eleven species of submergent aquatic plants.
